TRANSPORTATION RESEARCH CENTER

ON-SITE AIR BAG INVESTIGATION

CASE NO. - 96-11
FLEET - PRIVATE VEHICLE
LOCATION - PENNSYLVANIA
ACCIDENT DATE - [REDACTED], 1996

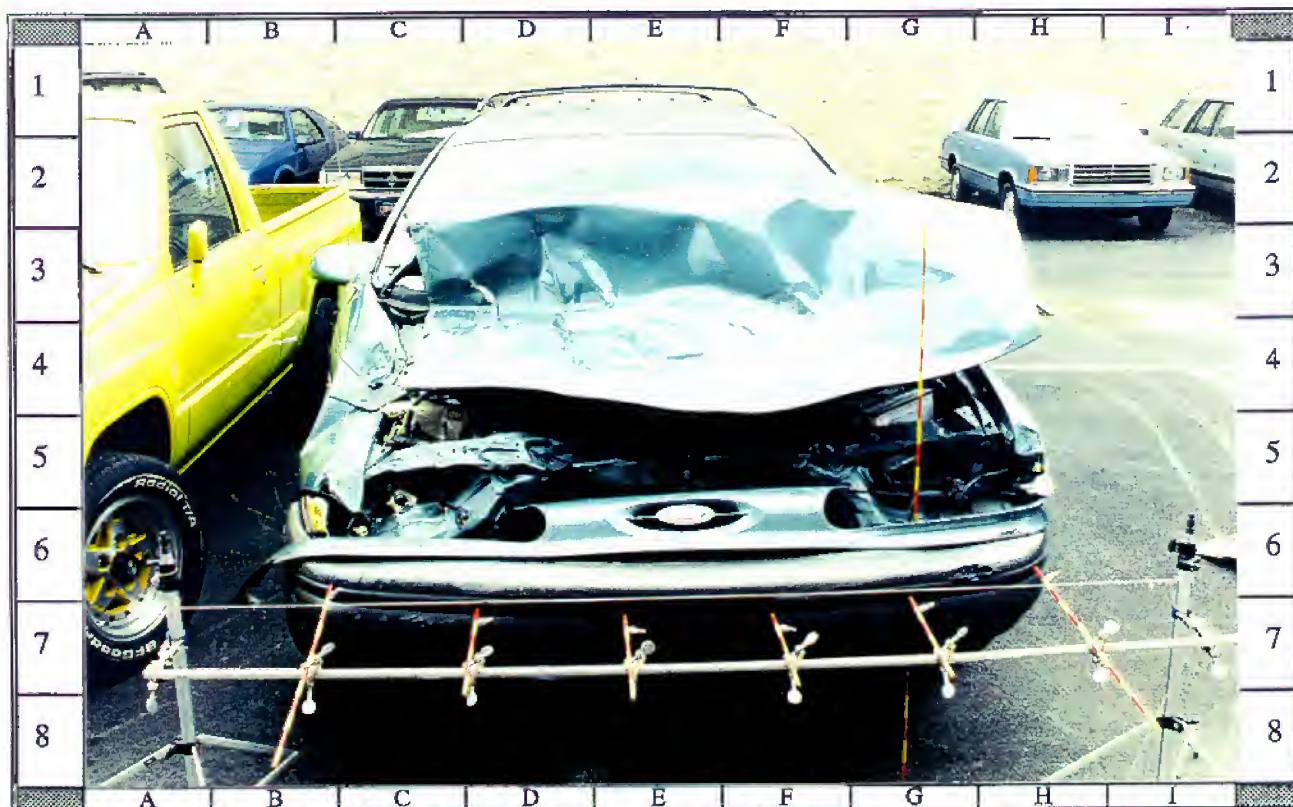
21: Case Vehicle's damaged front viewed from bumper level with contour gauge present at bumper level; NOTE: primary damage is above bumper

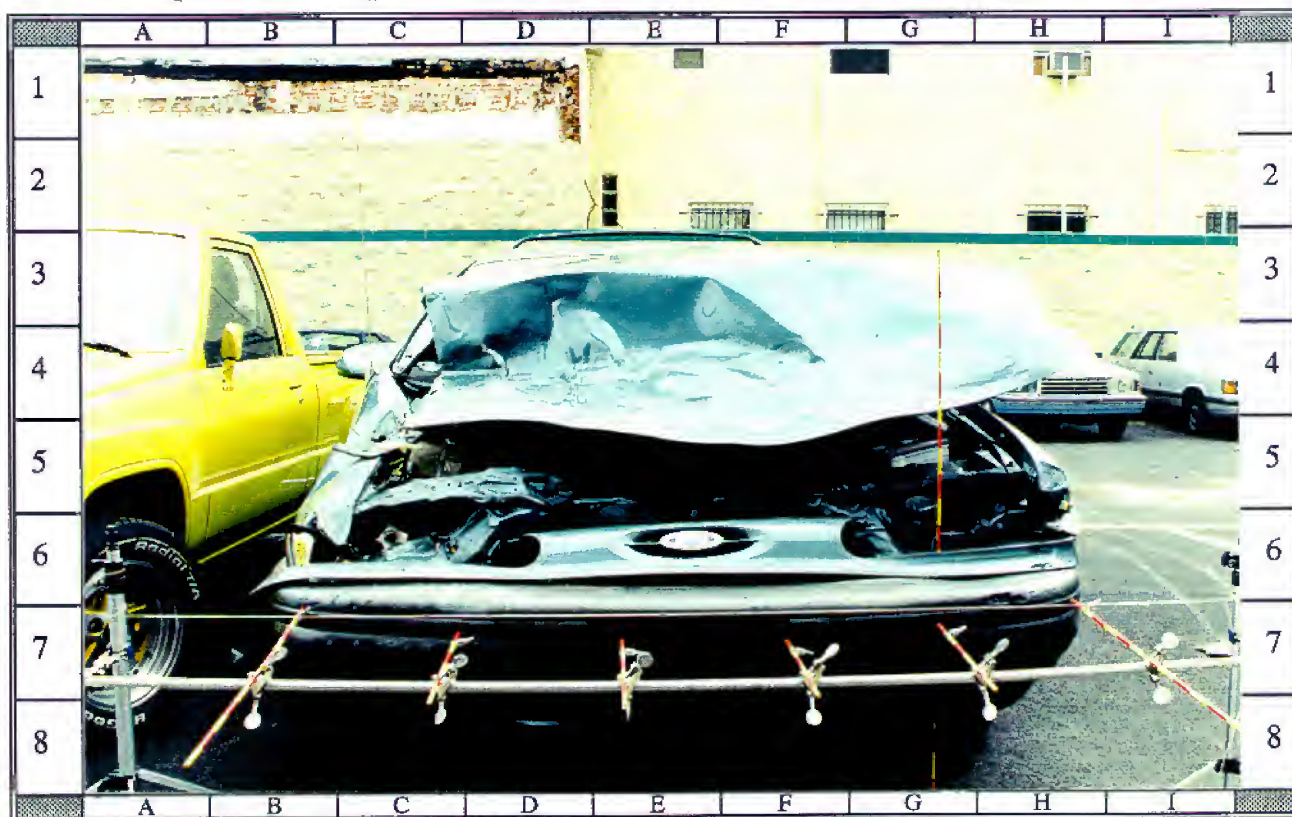
22: Case Vehicle's damaged front viewed from above bumper level; NOTE: hood shifted to left during rotation with 1995 Dodge Ram Van

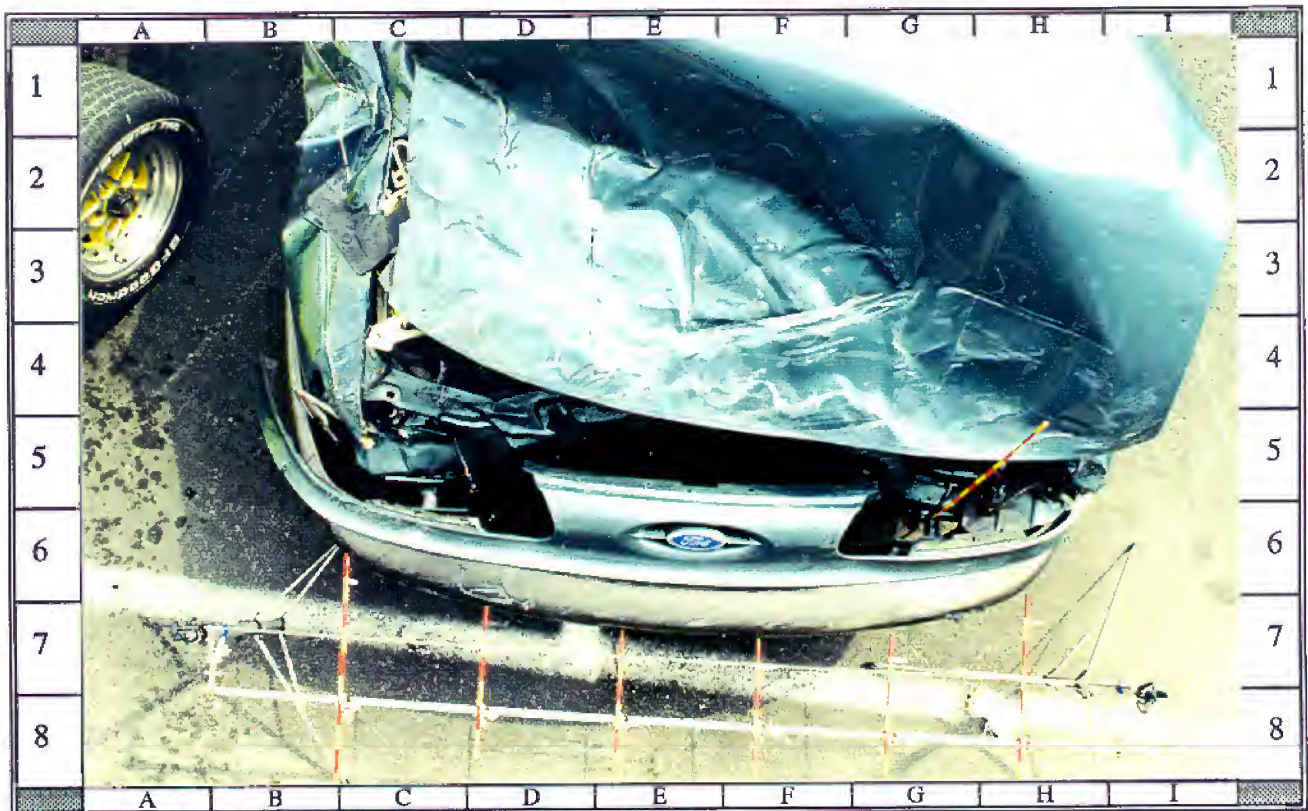
23: Overhead view of Case Vehicle's frontal crush; NOTE: hood damage pattern and right (cell C5) and left (cell G6) "EAD"s

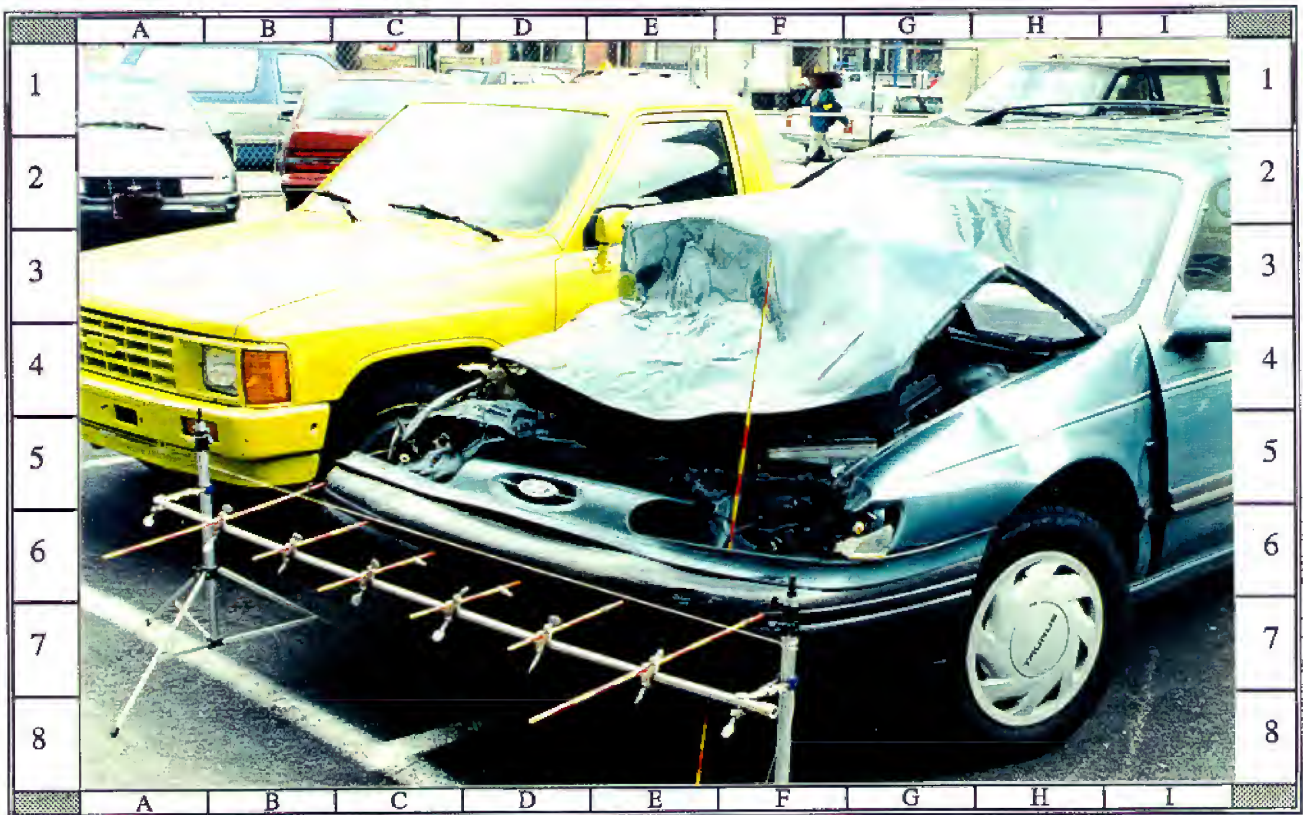
26: Case Vehicle's damaged front viewed from approximately 45 degrees left of front with contour gauge present at bumper level crush

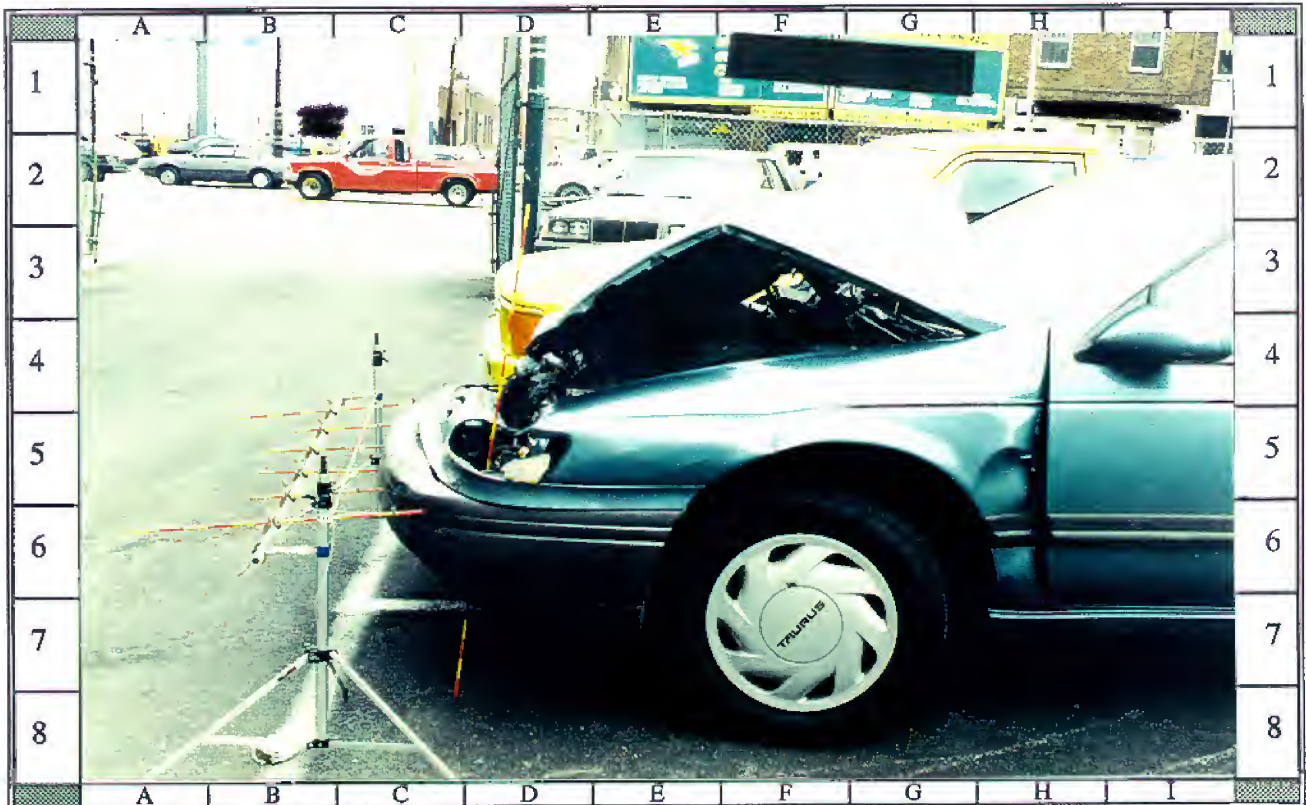
27: Reference line view from left of Case Vehicle's frontal damage showing uneven damage pattern; NOTE: induced damage to left fender near door

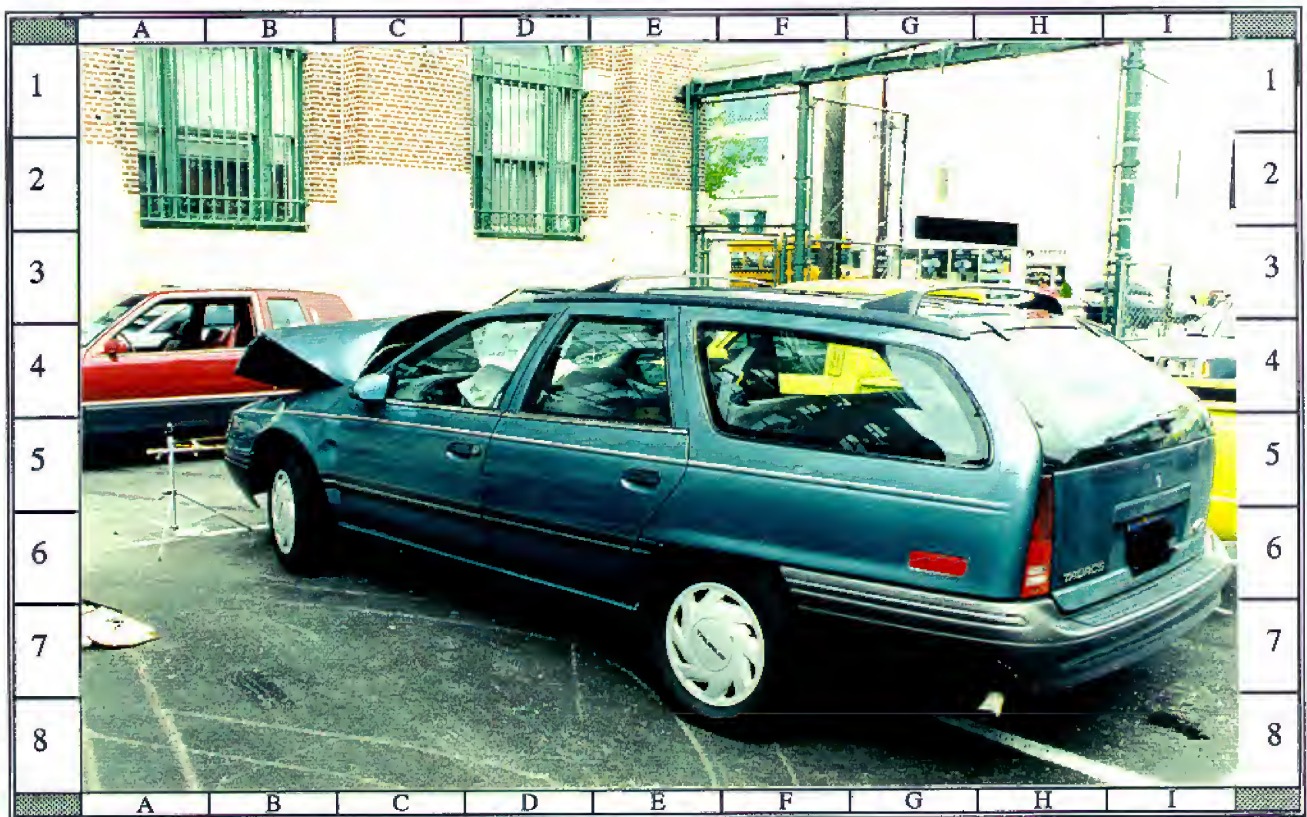
28: Case Vehicle's left side, showing induced damage to left fender, and undamaged back viewed from approximately 60 degrees left of back

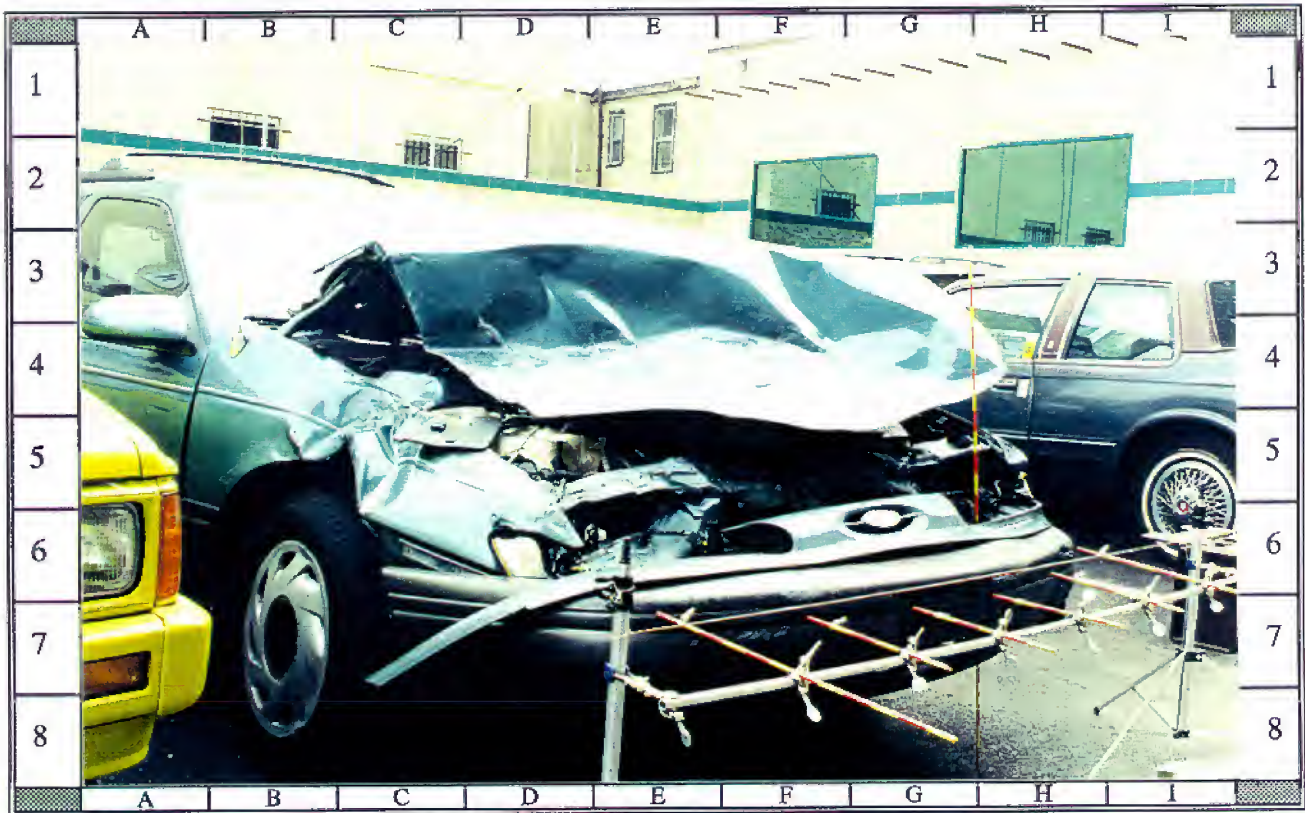
31: Case Vehicle's damaged front viewed from approximately 45 degrees right of front; NOTE: direct damage to right fender and right front wheel

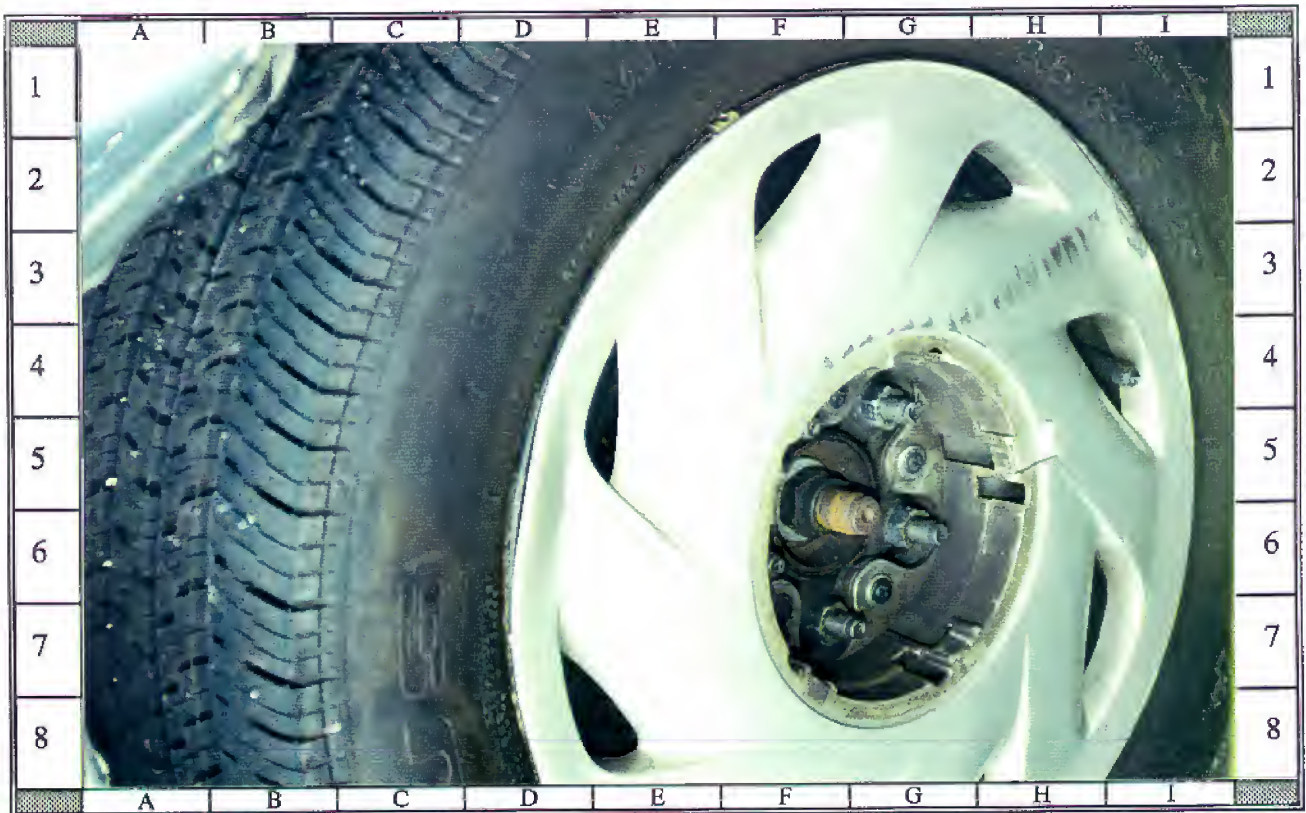
33: Closer-up view of direct contact to Case Vehicle's right front hubcap caused by 1995 Dodge Ram Van's left rear tire during counterclockwise rotation

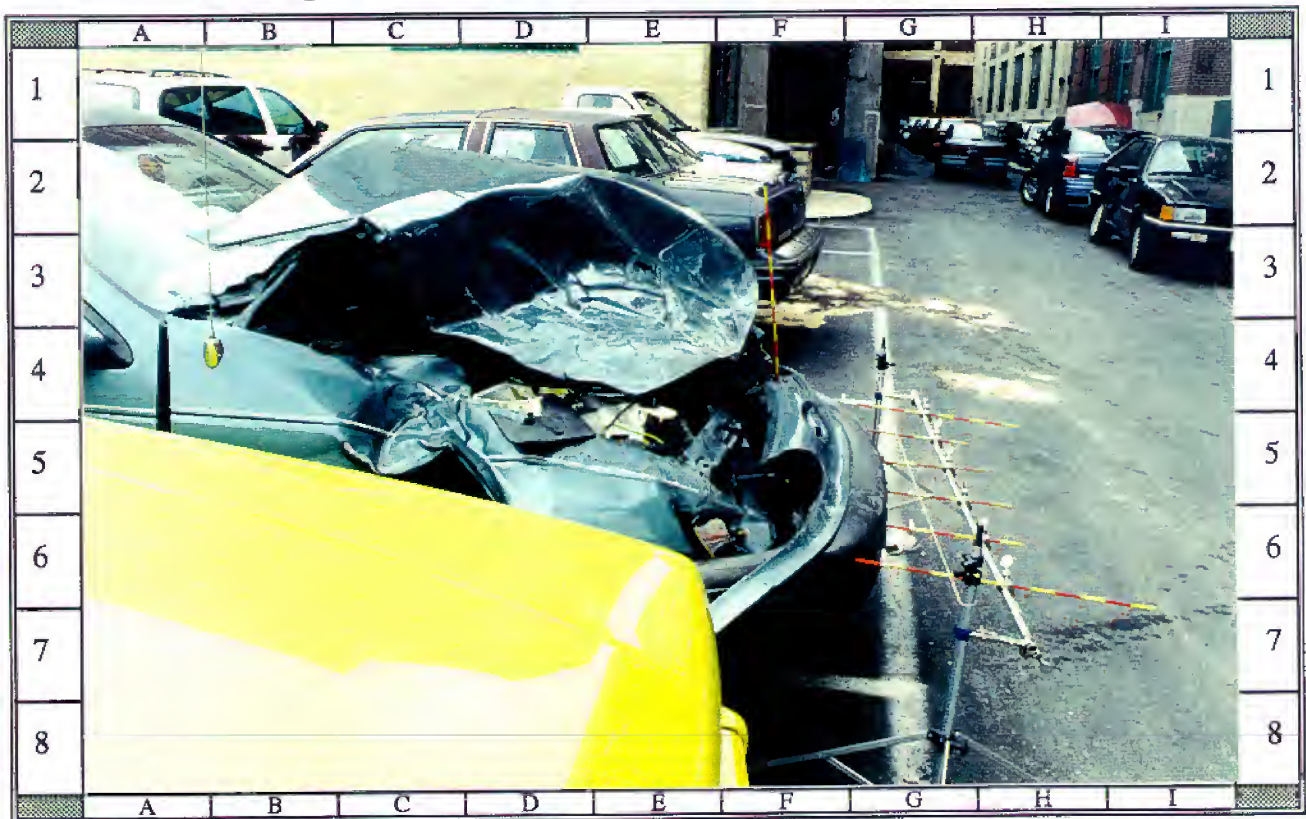
34: Reference line view from right of Case Vehicle's frontal damage; NOTE: uneven damage pattern between bumper level versus above bumper crush

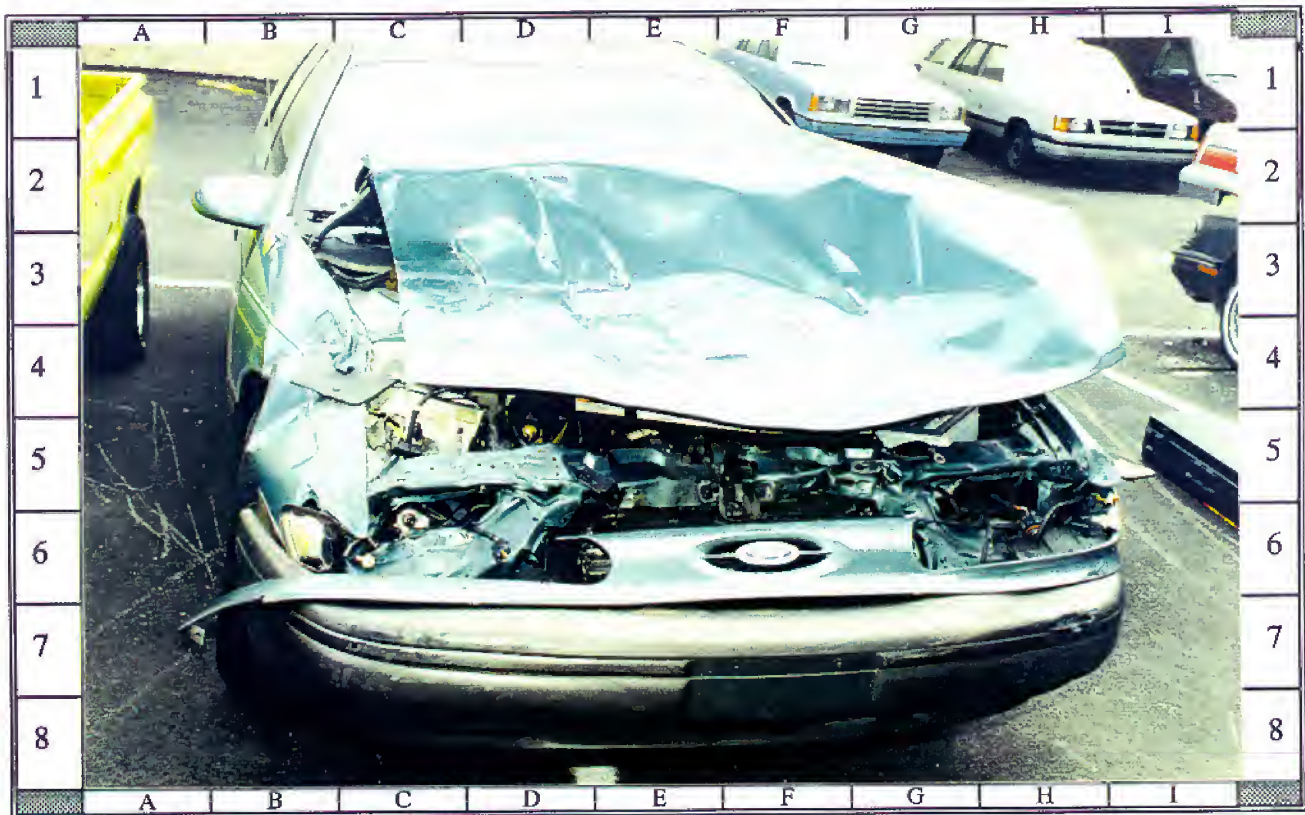
35: Case Vehicle's frontal damage viewed from approximately 10 degrees right of front without contour gauge present; NOTE: direct damage to right fender

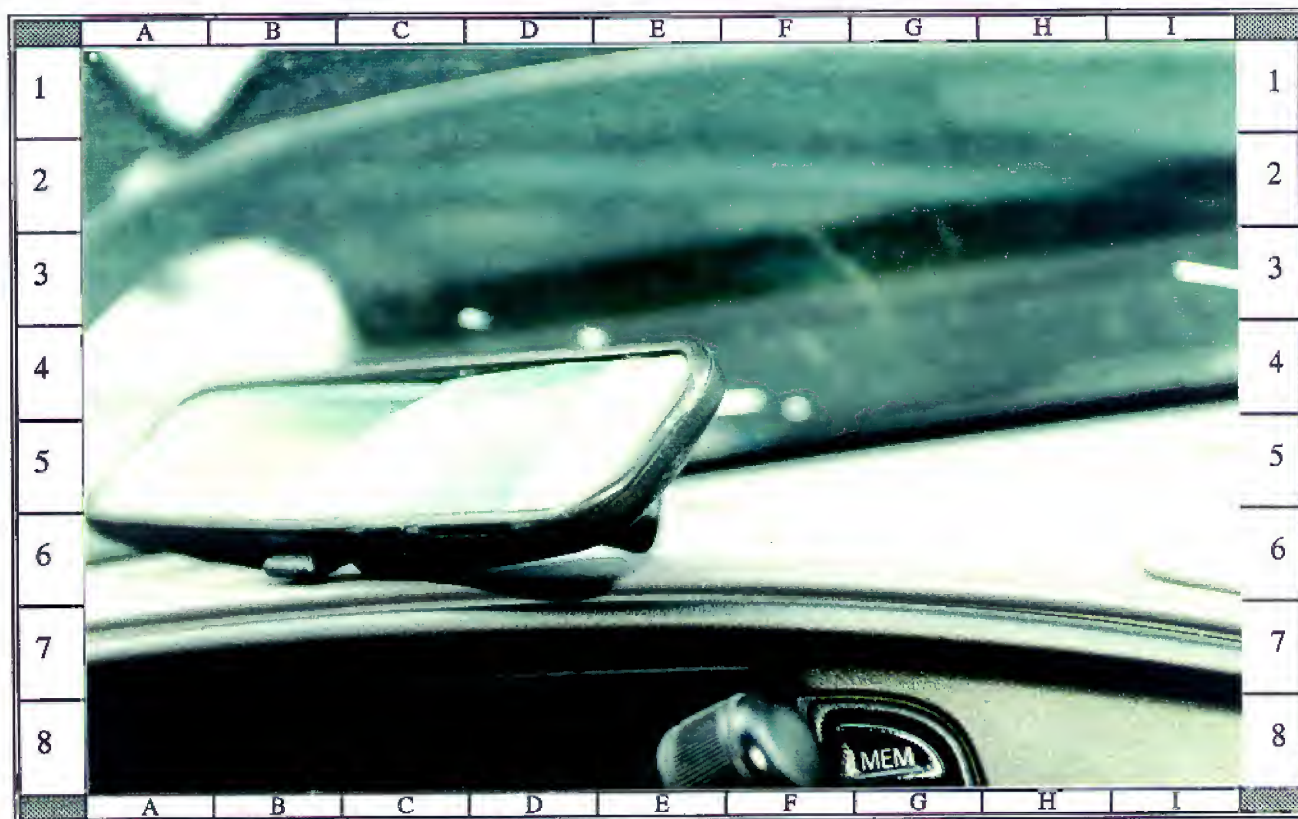
48: Close-up of scuffing to right side of Case Vehicle's rearview mirror caused from deploying right front passenger air bag

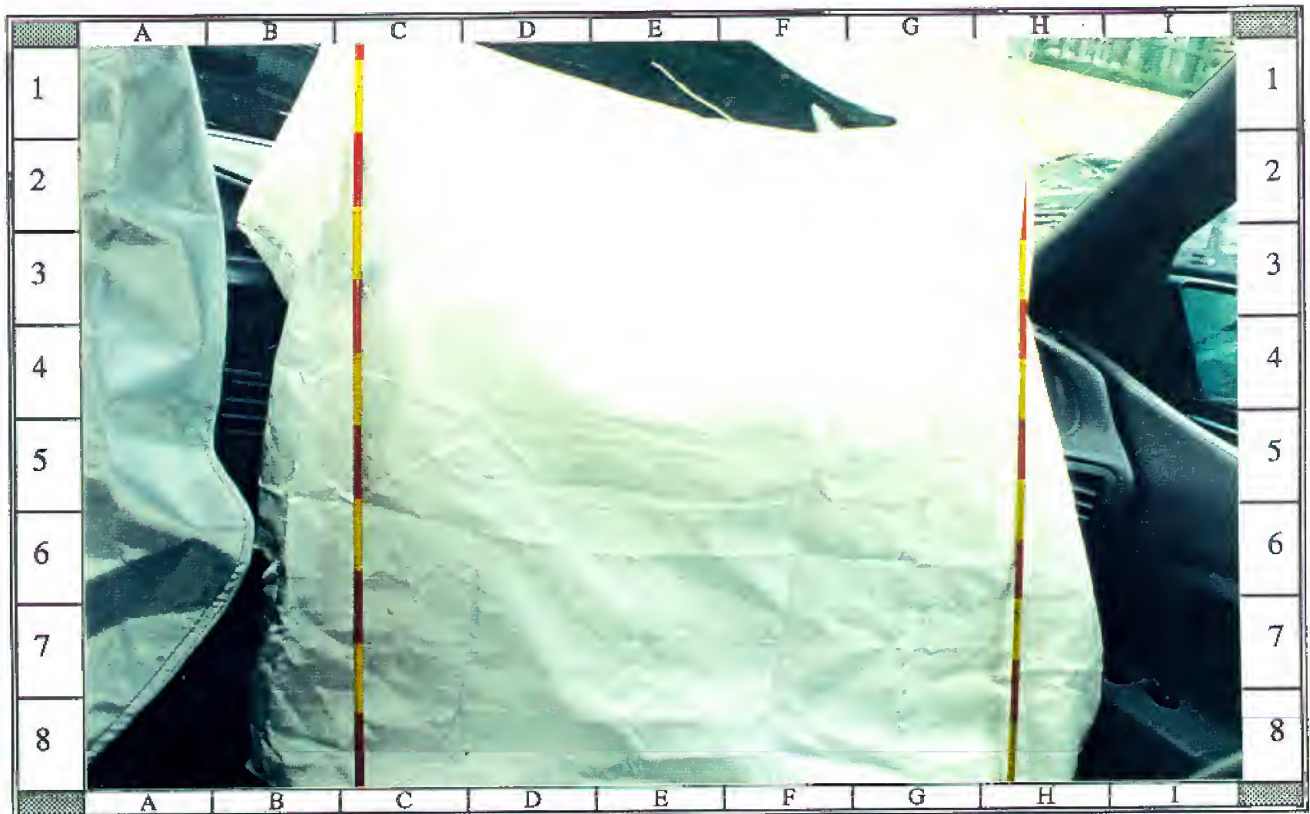
51: Close-up of Case Vehicle's deployed right front passenger air bag; NOTE: no evidence of contact on air bag--found only newsprint

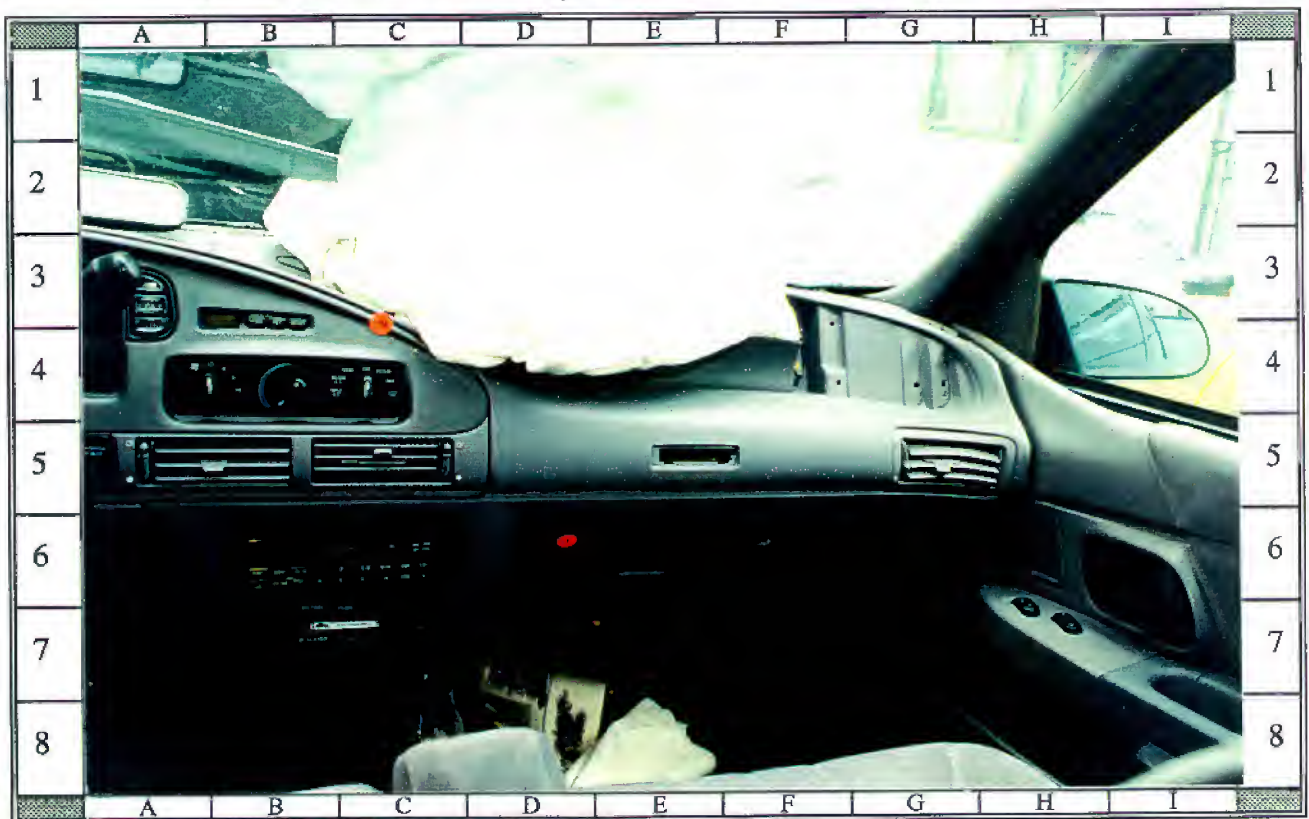
52: Case Vehicle's center and right dash and glovebox showing possible contact evidence; NOTE: missing dash panel (cell G4)

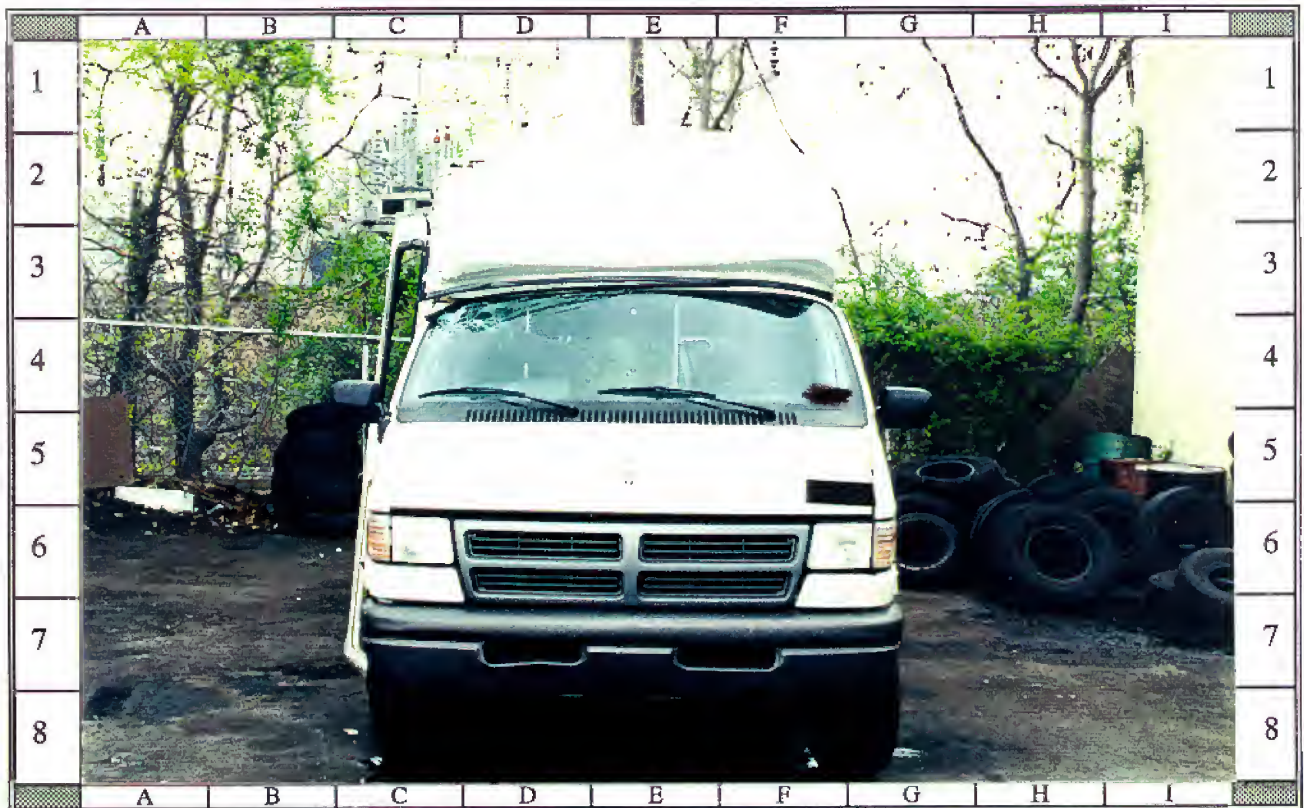
57: Vehicle #2's undamaged front; NOTE: windshield and roof damage occurred during rollover (cells C2--D4)

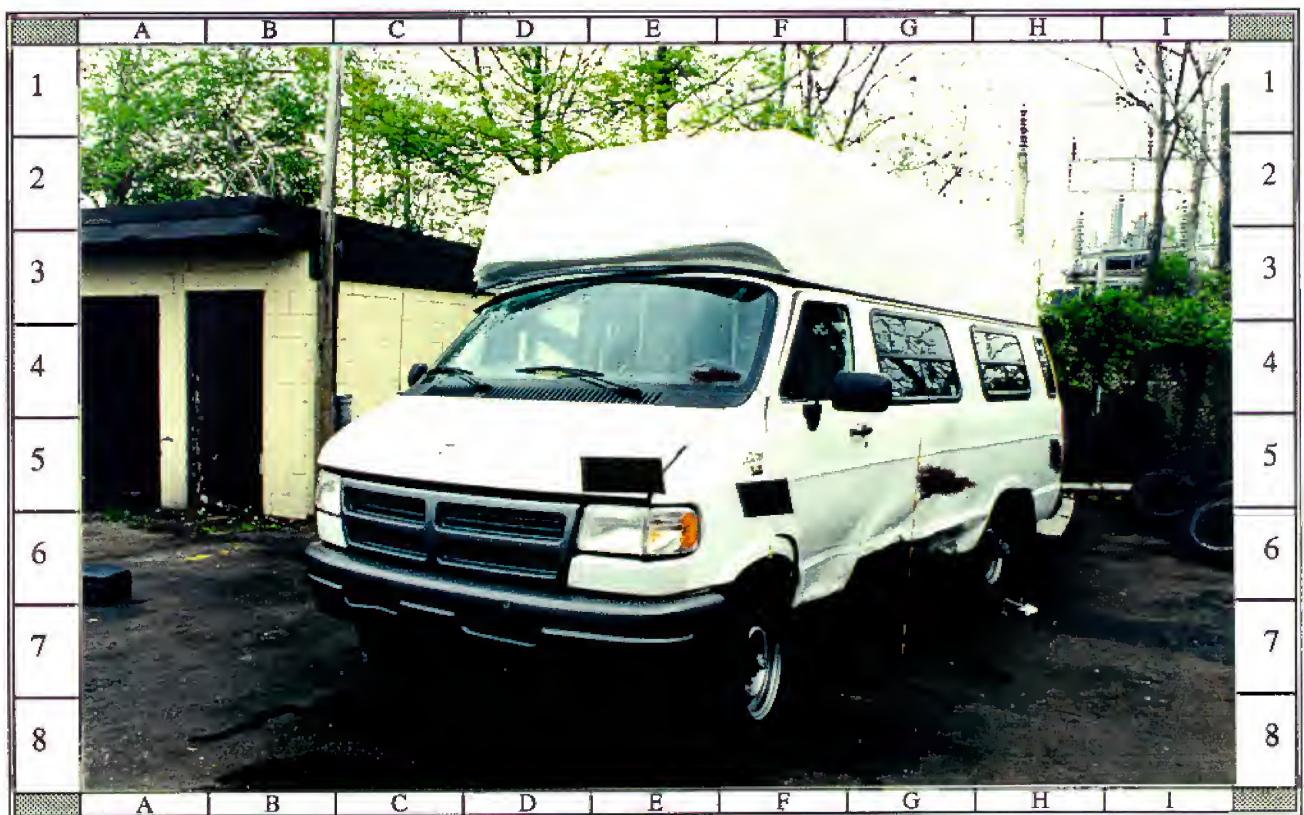
58: Vehicle #2's undamaged front and damaged left side viewed from approximately 45 degrees left of front

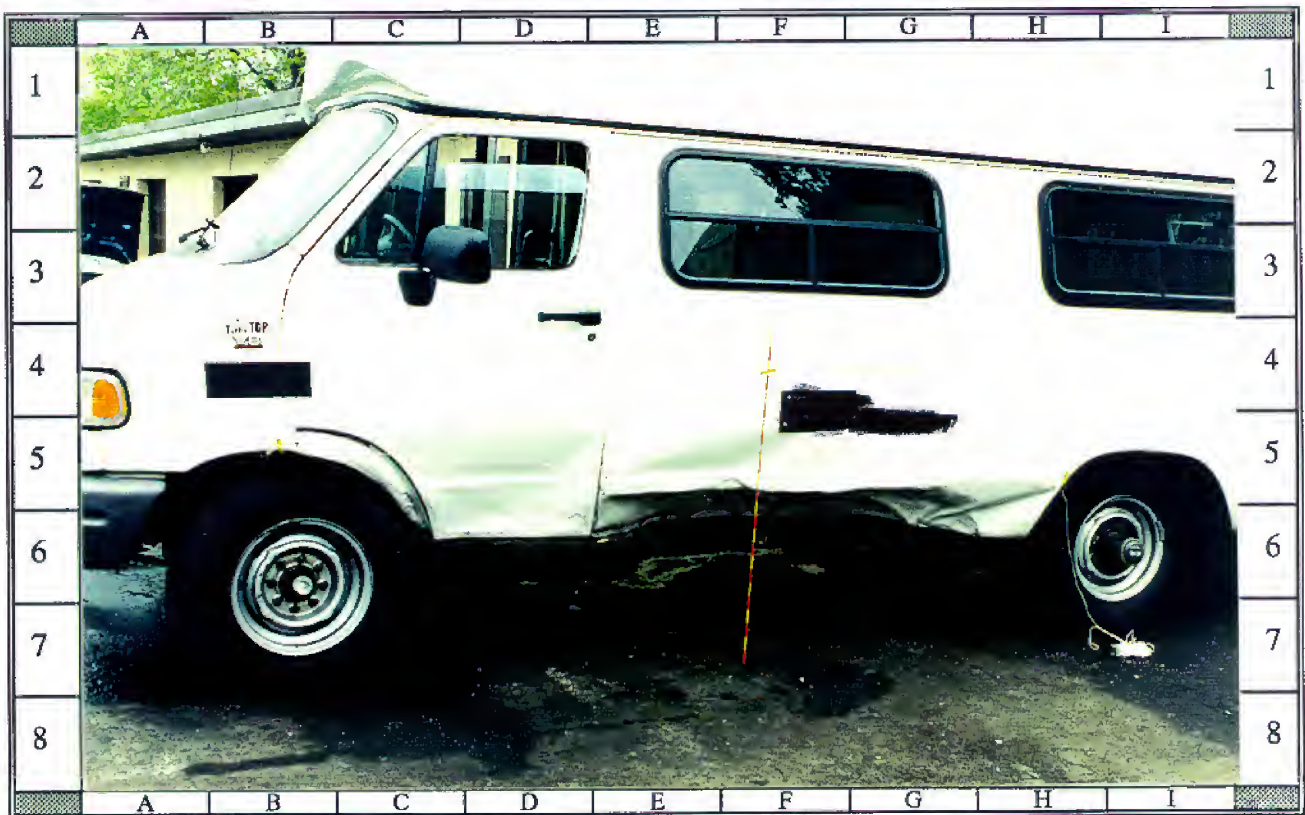
60: Vehicle #2's damaged left side viewed from approximately 75 degrees left of front; NOTE: direct damaged begins at center of left front hub cap

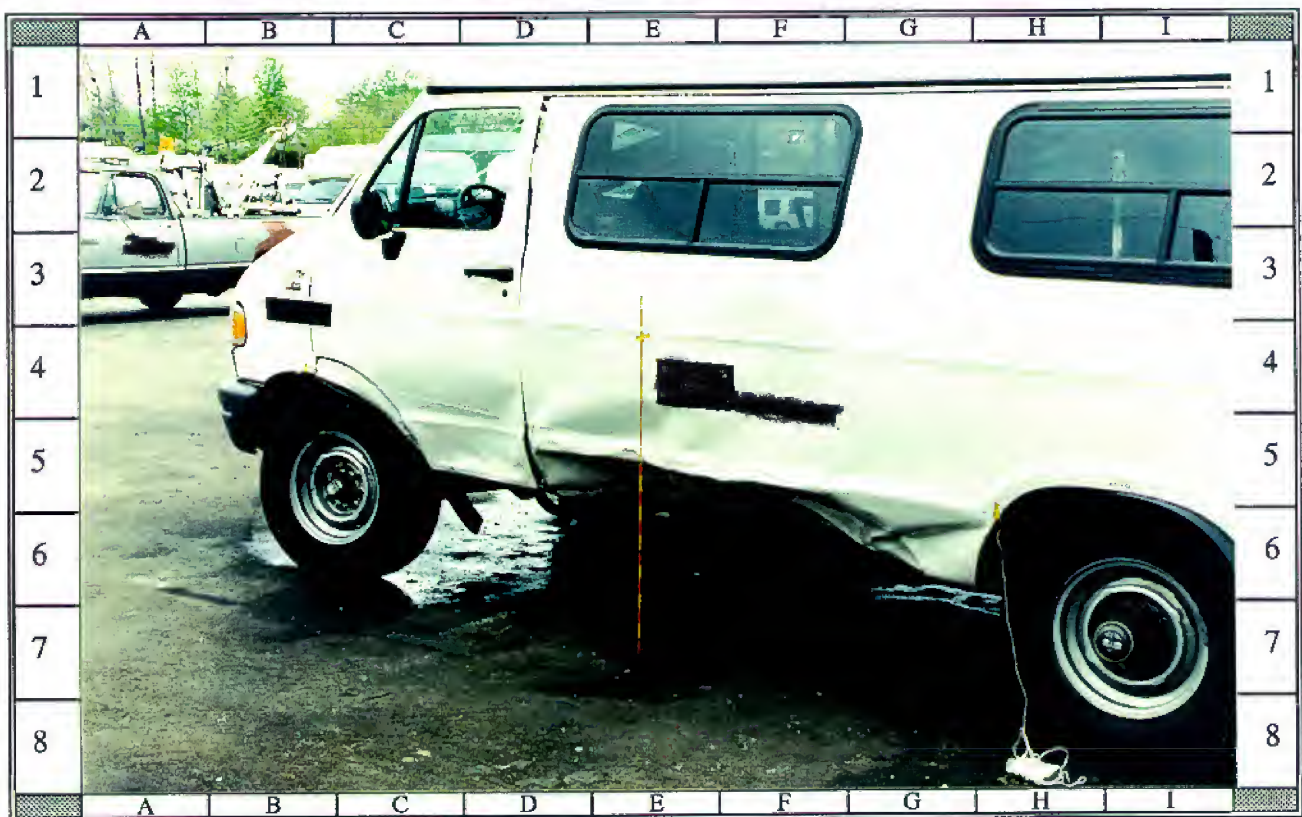
62: Vehicle #2's damaged left side viewed from approximately 60 degrees left of back; NOTE: override type damage from impact with 1992 Ford Taurus

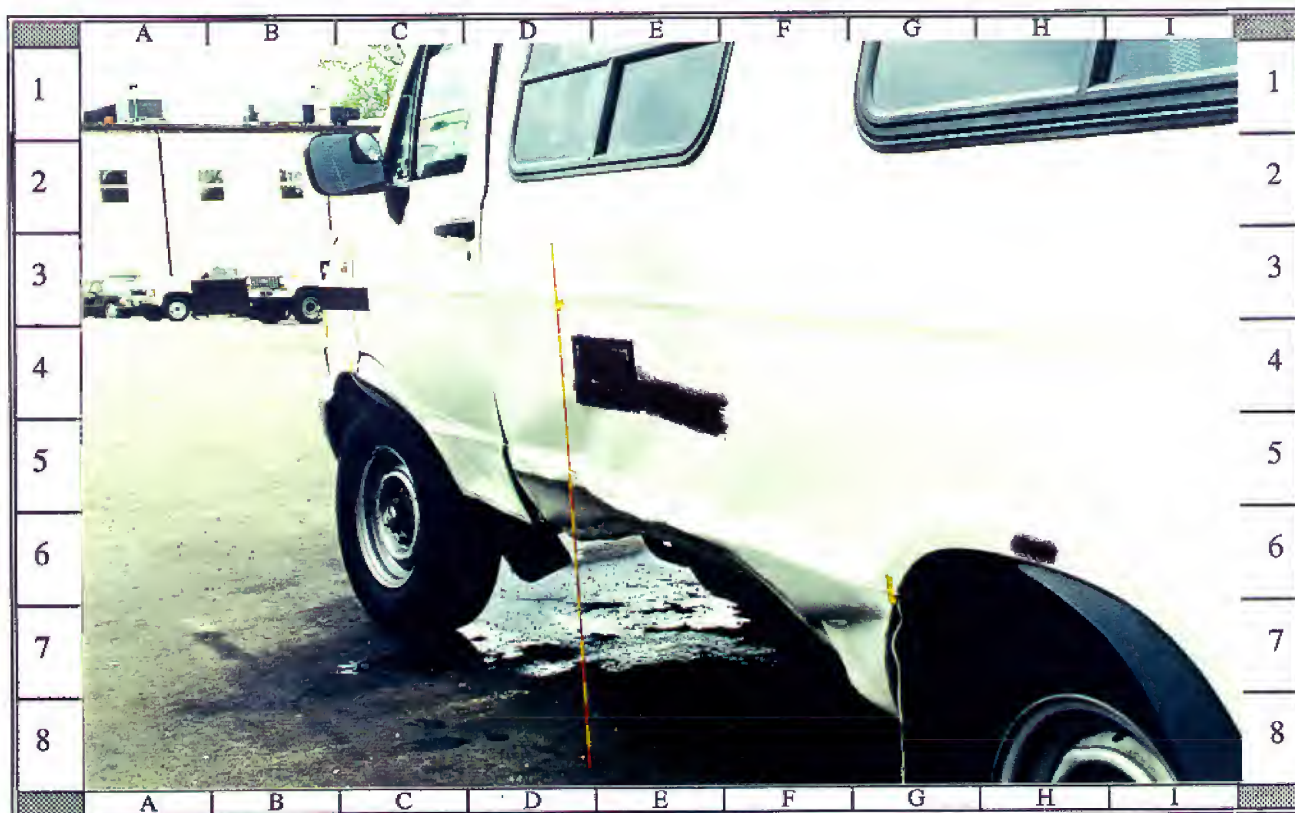
63: Vehicle #2's damaged left side viewed from approximately 30 degrees left of back; NOTE: splash guard behind left rear wheel (cells H6--I8)

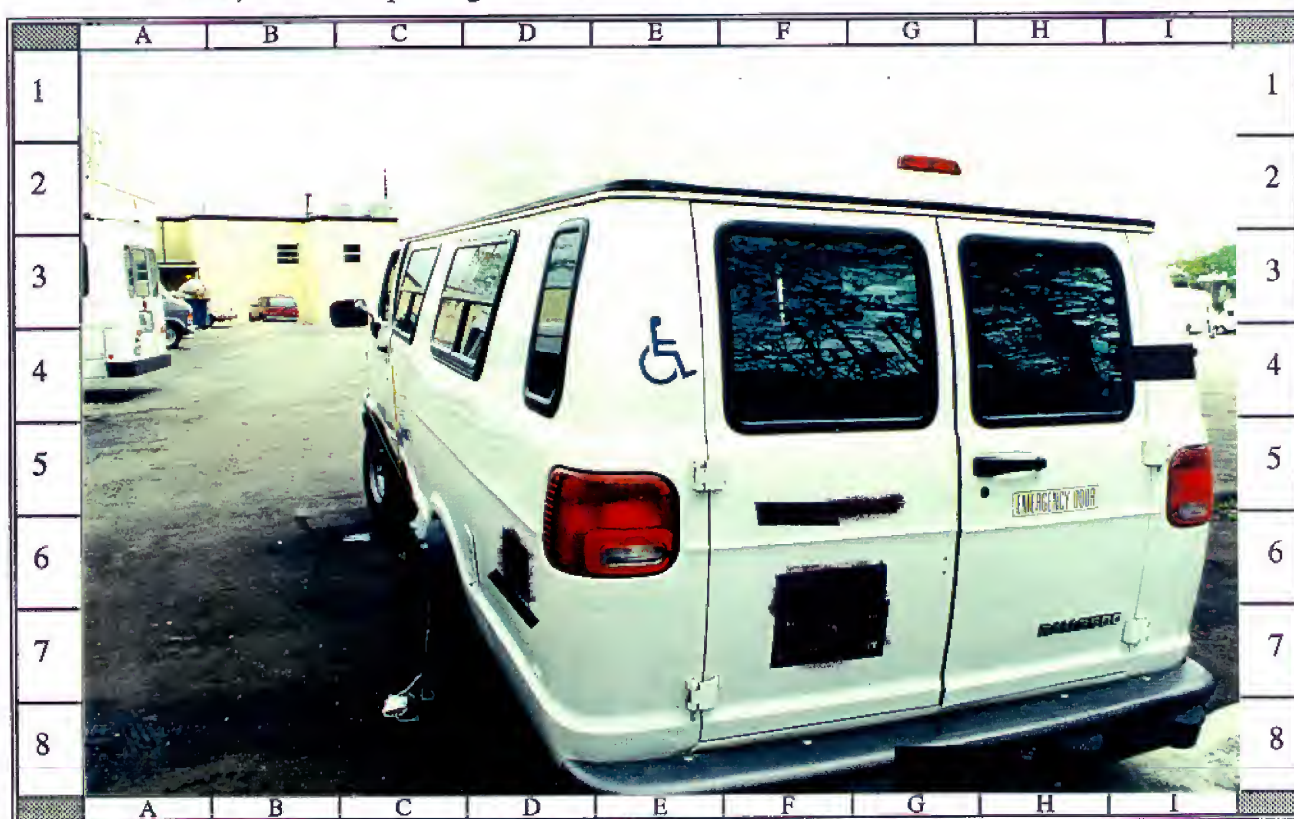
64: Vehicle #2's undamaged back and damaged left side viewed from approximately 15 degrees left of back; NOTE: splash guard behind left rear wheel

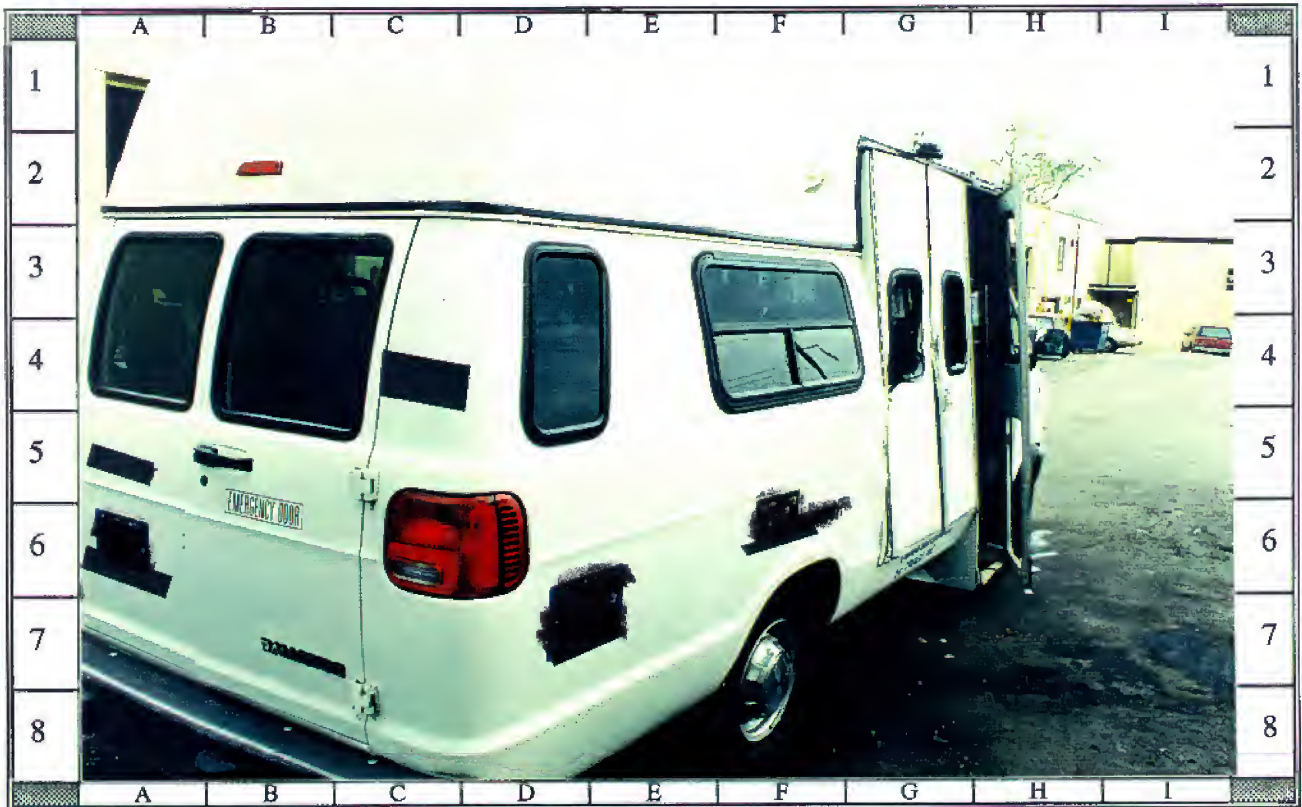
65: Vehicle #2's undamaged back and damaged right side viewed from ~ 30 degrees right of back; NOTE: right side struck light pole and mailboxes during rollover

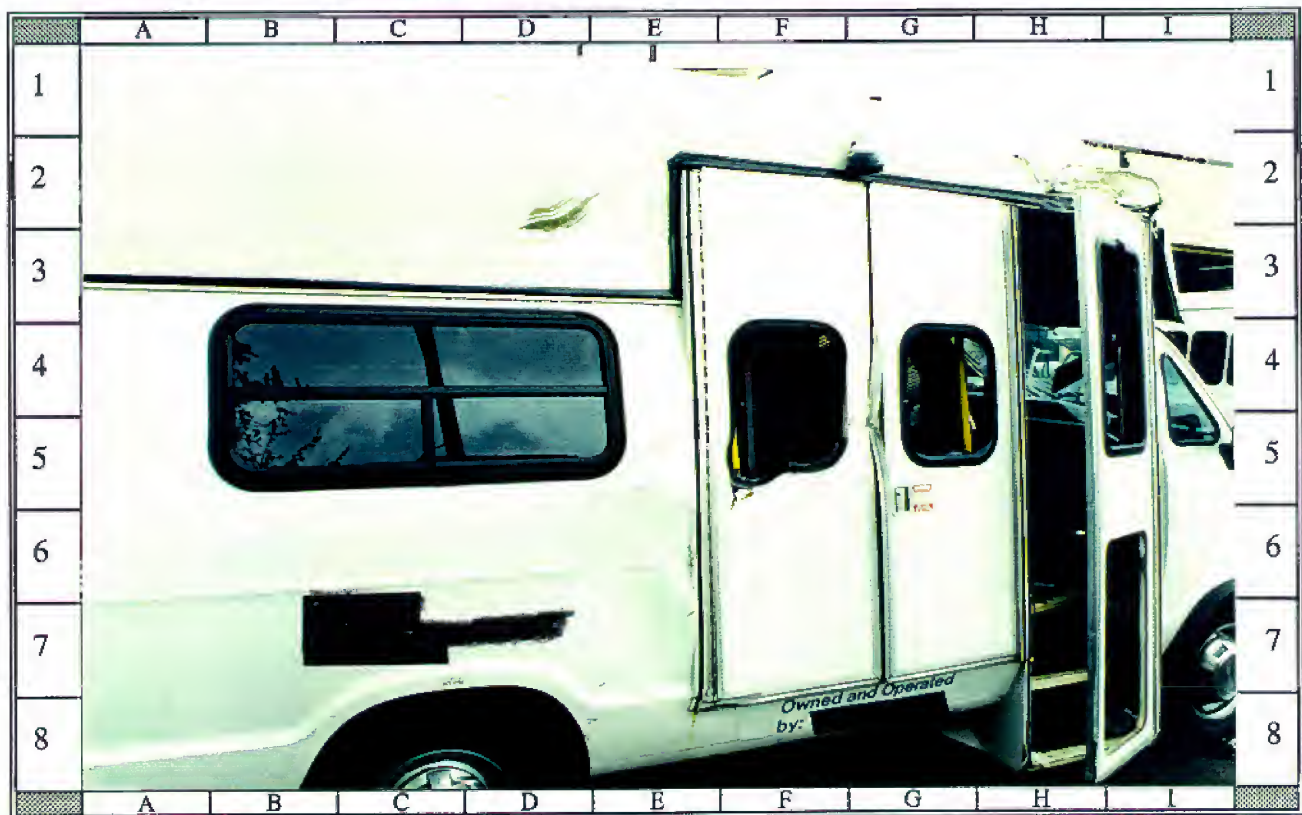
66: Vehicle #2's damaged right side showing light pole damage behind double doors and mailbox damage to double doors; NOTE: all door windows were shattered
